Home Inspection Service

Sample Report

1 Main St
Fairfield, CT

Monday, August 16, 2004

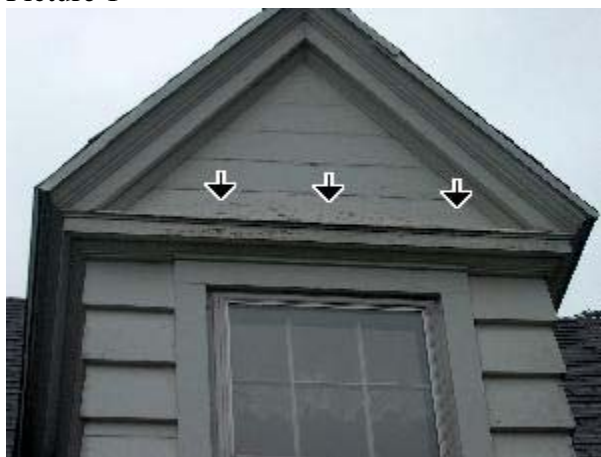
Picture 1

Most of the paint on the house is serviceable, but some areas of the trim are in need of paint.

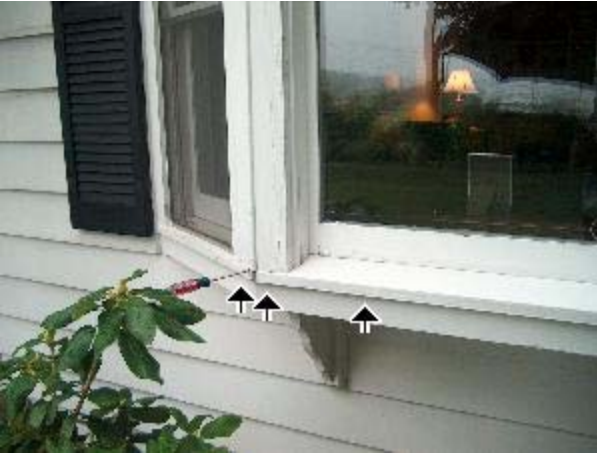
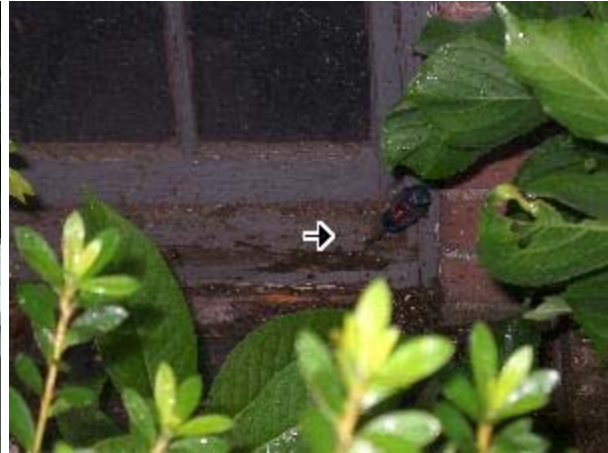
Comments: Inspected, Repair or Replace
The trim on the bay and cellar windows is rotted and should be repaired by a carpenter.

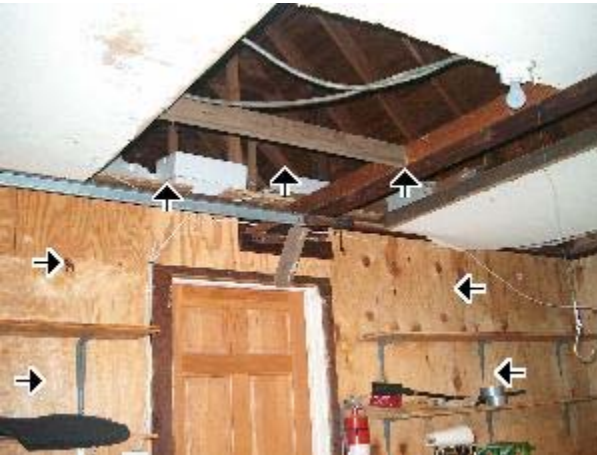
Picture 1

Comments: Inspected, Repair or Replace
Damaged wall and ceiling finishes of attached garages should be repaired where they abut the interior of a house. This reduces the potential of toxic automobile gases entering the house and serves as a fire break. Openings should be sealed for your protection.

Pronounced floor cracks were noted in the garage. While this amount of cracking is unusual, this slab is not a structural component.

The overhead garage door is substantially rotted. It should be repaired or replaced as necessary.

The door between the house and garage should be weather-stripped and fitted with an automatic

closer. This will reduce the potential of toxic automobile gases entering the house.

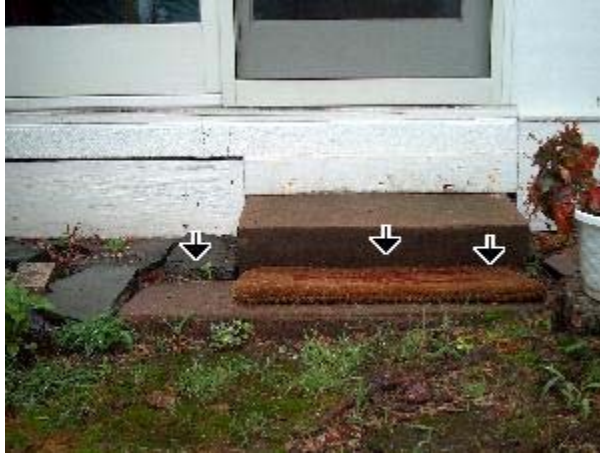
The steps off the breezeway have settled. This represents a trip hazard and should be corrected by a reputable contractor.

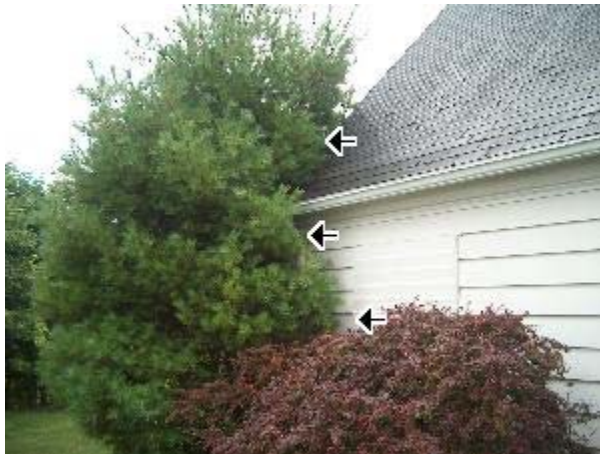
Landscaping is well established but in need of general pruning and trimming. Foundation plantings and shrubbery should be trimmed to avoid any contact with the home.

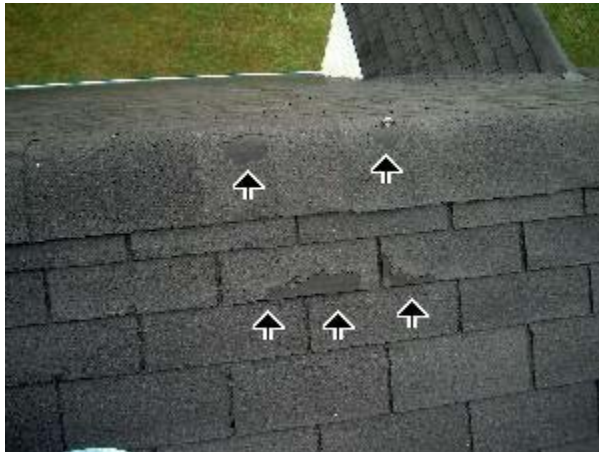
Picture 1

While the useful remaining life of this roof covering is impossible to predict, it is nearing the end of its life cycle. Replacement would be a logical short term goal.

It is recommended that the present layers of roofing materials be removed prior to re-roofing. This adds cost of demolition and debris removal to the re-roof cost.

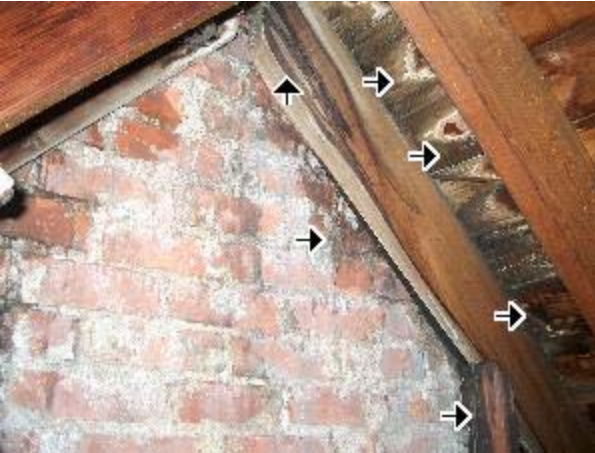
Chimney has no step or cap flashing and needs repair. Roofing cement has been used as flashing and appears to be leaking. Patching should be attempted. If this is unsuccessful, replacement may be necessary. The Chimney should be properly flashed when the roof is replaced.

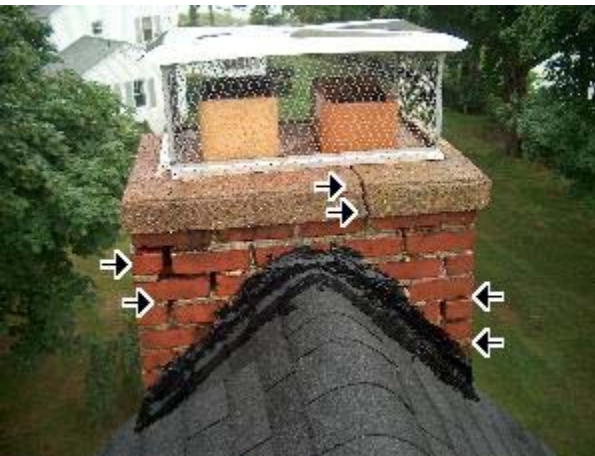
Picture 1

Weathering and/or cracking of the mortar crown has been noted at the masonry chimney. This has resulted in moisture entry into the masonry and subsequent damage at the top courses of brick. Rebuilding of the crown and repointing of missing or deteriorated mortar is recommended.

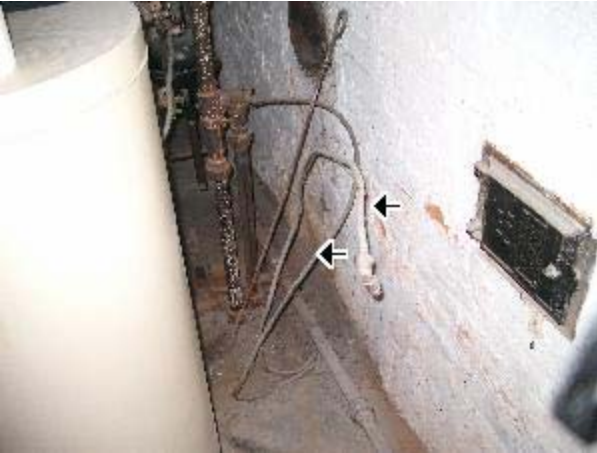
There are abandoned oil lines present in the basement, this combined with the history in the neighborhood could suggest that an underground oil storage tank exists on the property. According to the Environmental Protection Agency (EPA), this situation can represent a significant environmental risk. In most cases, these tanks must be removed. Contaminated soil around the tank, if any, should be also be removed. The cost for this work can be substantial. It is recommended that you check with the town records to see if in fact a tank has been removed. If no history is found then a specialist should be consulted to further investigate.

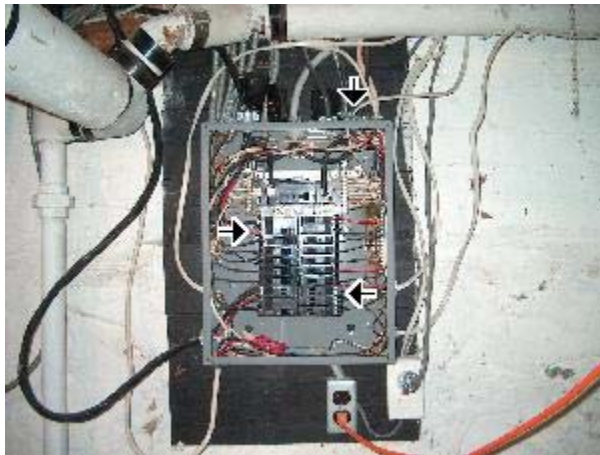
Several breakers within the panel have undersized wiring and should be corrected. One of the wires coming out of the panel is loose and should be reconnected. Recommend a licensed electrician inspect further and correct as needed.

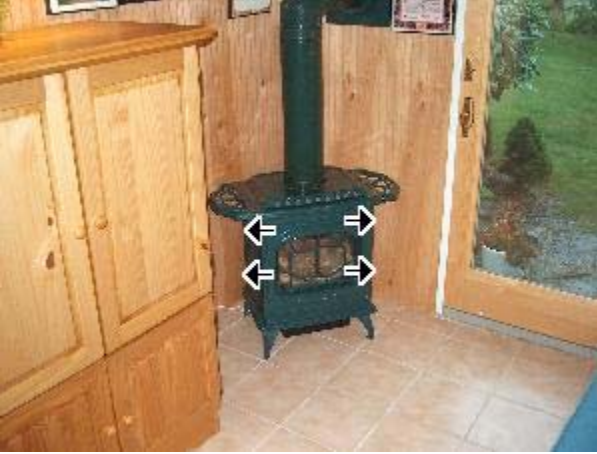
Picture 1

Comments: Inspected, Repair or Replace
Clearance from the gas fired Woodstove to wall is too close and needs fire rated wall board or approved decorative panels placed on wall.

It also appears the venting system is too close to both the eave and the window.
I recommend contacting a fireplace specialist to make necessary corrections to ensure operating safety.

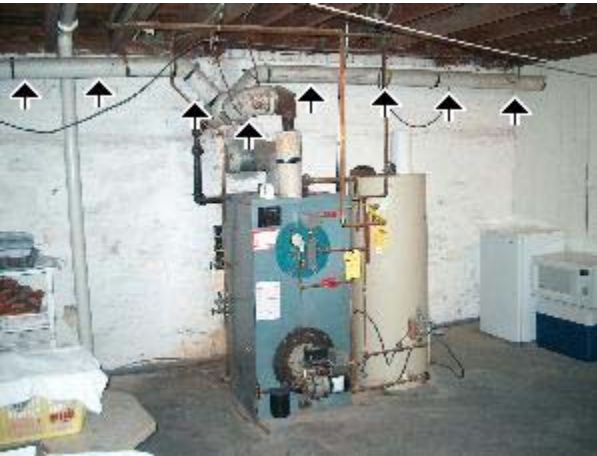
Comments: Inspected, Serviceable
There is what appears to be an asbestos type material covering the heating pipes. This can only be verified by laboratory analysis which is beyond the scope of this inspection. The EPA reports that asbestos represents a health hazard if "friable" (damaged, crumbling, or in any state that allows the release of fibers). Some of the sections of the insulation are indeed friable, I recommend a specialist should be engaged to determine the best way to remediate the situation.

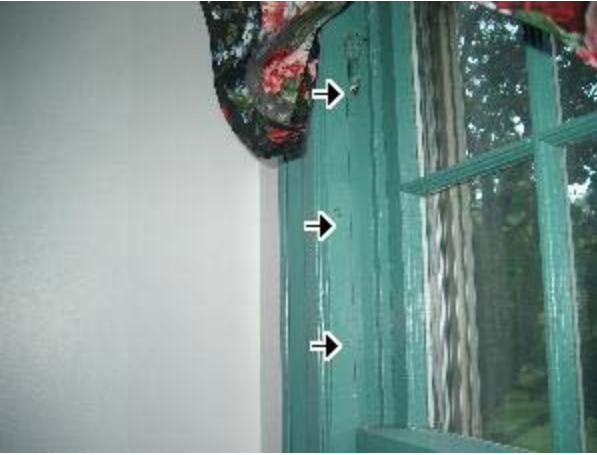
Many of the windows on the 2nd floor are missing one of the ropes needed to hold the window in an open position.

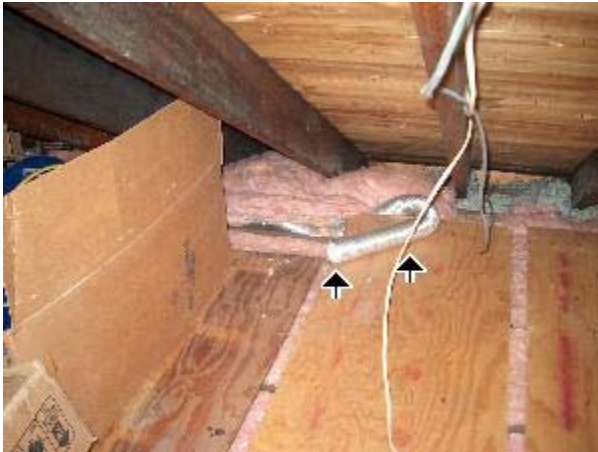
Exhaust fan is does not vent to outside at Upstairs Bath. (Pic)
